# Replacement Notes for : ETS, 10-pin

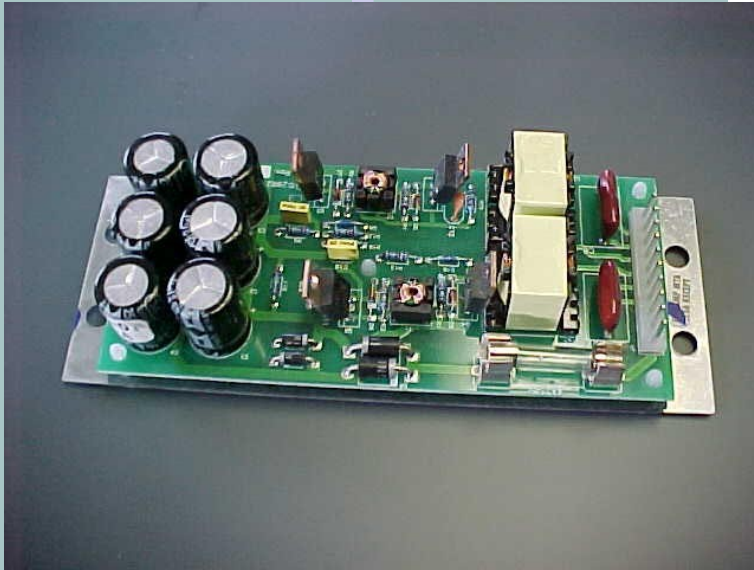
10-pin ETS ballast, pictured at left, is replaced by the FA100 ballast using the existing input harness from the tanning unit. The existing 8-pin output harness from the tanning unit plugs directly into the FA100 output connector. Note that the input and output connectors are on opposite ends of the FA100.
