Replacement Notes for : FST 10-pin, Double

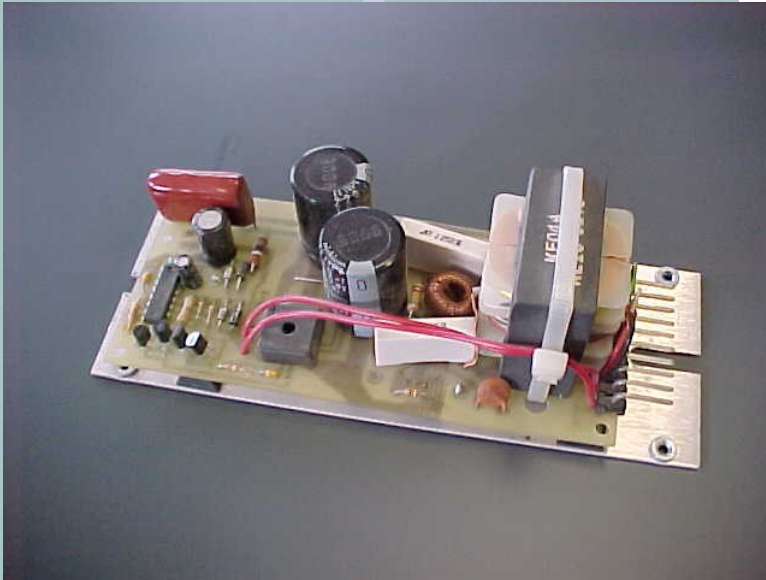
The double FST 10-pin replacement ballast, pictured at left, is replaced by the FA100 ballast using the existing input harness from the tanning unit. The existing 8-pin output harness from the tanning unit plugs directly into the FA100 output connector. This ballast was typically used as a replacement for Kesio style ballasts.
