# Replacement Notes for : Kesio, 8-pin

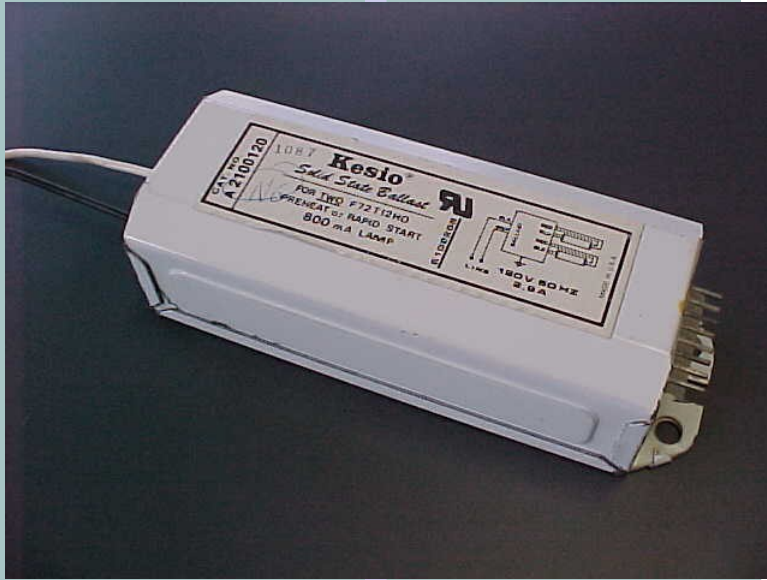
8-pin Kesio ballast, pictured at left, is replaced by the FA100 ballast using the existing hard-wired input harness from the tanning unit. The existing 8-pin output harness from the tanning unit plugs directly into the FA100 output connector. For an input connection that can be unplugged instead of the original hard-wired input, splice in our 2-2IN-K harness pictured below which easily plugs into the FA100 input on the ballast.

Note: Some of these ballasts also had black cases with and without identifying labels. These ballasts were typically labeled with A2100120.
